Fire Investigation Summary

Church Fire

Lake Worth, Texas

February 15, 1999

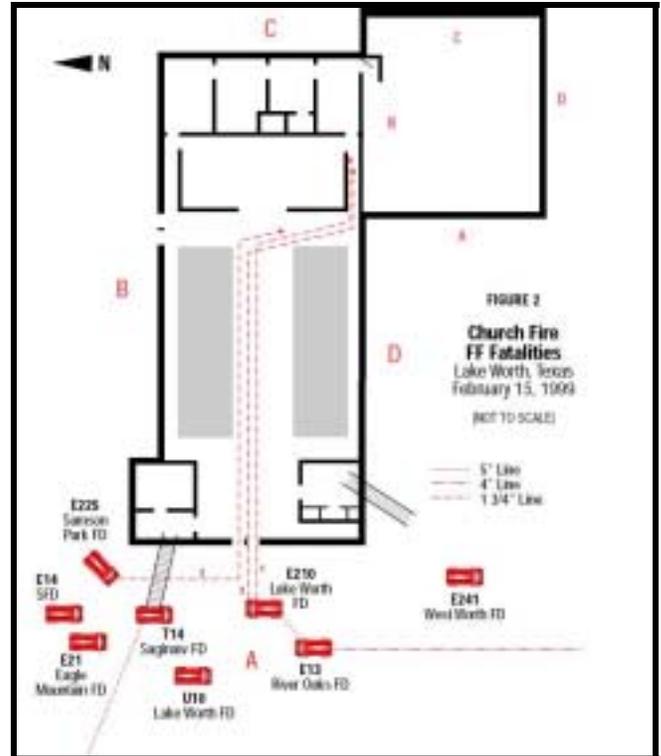
The collapse trapped the five fire fighters in the interior of the building in the southeast corner of the church near the wall shared with the Fellowship Hall. An initial accountability check revealed that two fire fighters were trapped in the building. A rescue attempt was attempted through the Fellowship Hall, and as a fire fighter entered the hall he found a door near where the trapped fire fighters were believed to be located. He was able to remove two of the five fire fighters inside the building, but was unaware that there were additional fire fighters trapped inside. Conditions deteriorated rapidly immediately following this rescue. A second more accurate accountability check was made, and it was realized that three fire fighters were still missing, two from River Oaks and one from Samson Park.

As the fire was being extinguished, the three fire fighters were found. Two were in a short corridor adjacent to the altar and the third was found in one of the offices on the east side.
